Small void on either side of truck after installing our 1979 + newer tub onto a STEEL COWL only

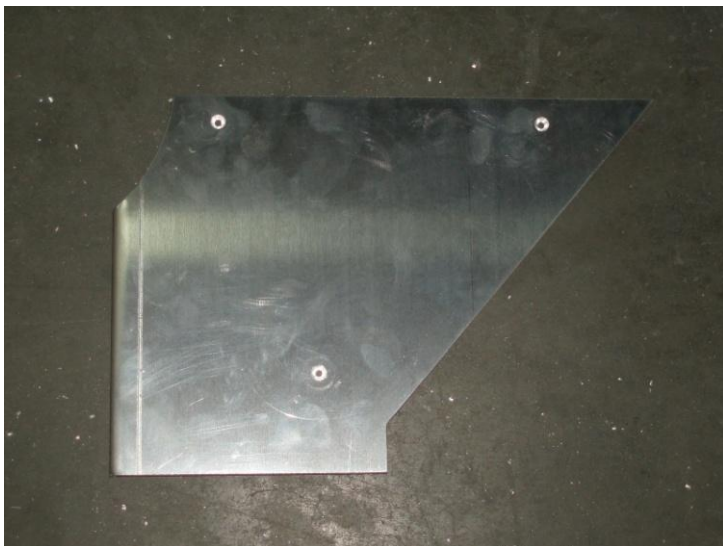
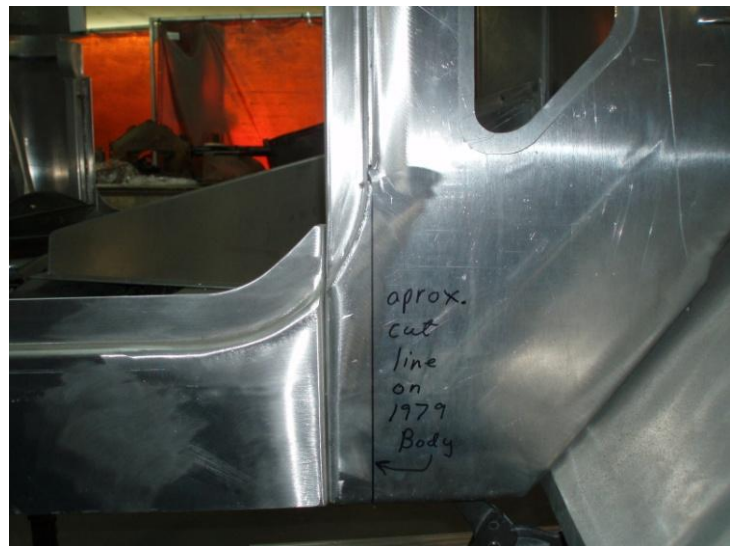
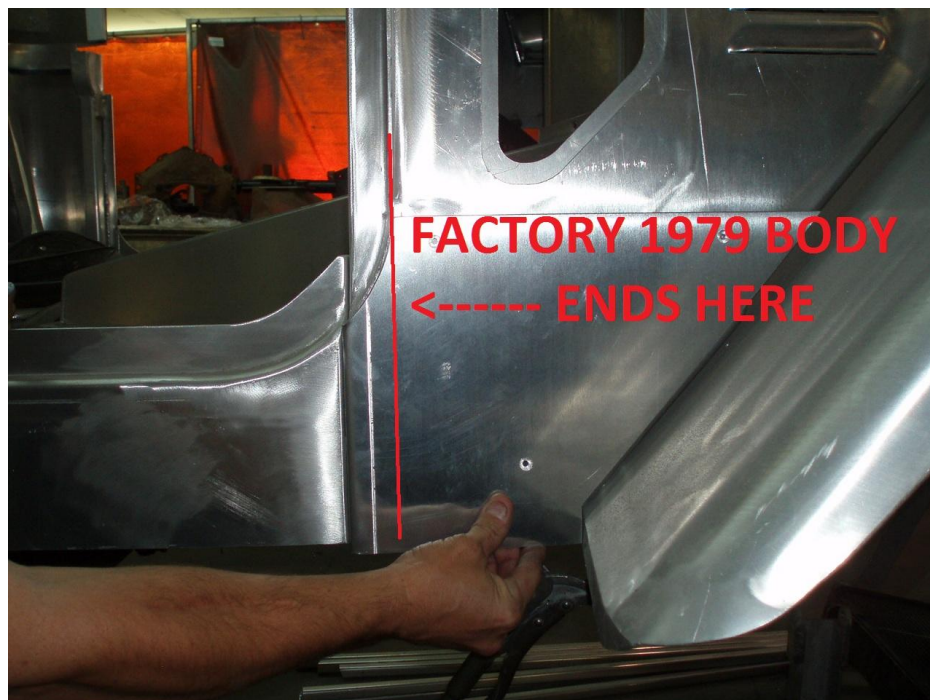
After your original tub has been removed and our replacement tub has been bolted into position you will be left with a small void on either side of your truck.

These cover plates will need to be secured to the exterior of your truck to conceal and at the same time strengthen this area.

Once these cover plates have been bolted into position we recommend running a small bead of seam sealer or Sikaflex around the outside perimeter to keep moisture out.

Another option is instead of using these cover plates is to weld a new piece of steel sheet metal to the existing front cowl. This sheet metal should have a 90 degree bend that ties back onto the door post. This will then give you a mounting surface to bolt the aluminum body to your existing cowl.
